CONSERVATION - RESTORATION WORKS ON CEILING PAINTINGS IN THE BAJAMONTI - DEŠKOVIĆ PALACE

CROATIAN
CONSERVATION
INSTITUTE

CONSERVATION – RESTORATION WORKS

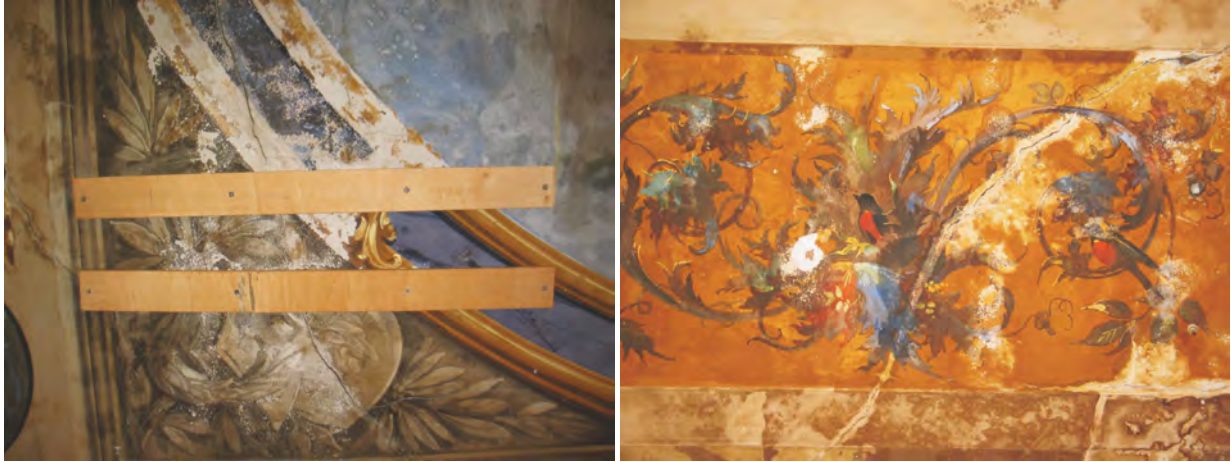
This difficult condition was additionally aggravated by the disarrangement of the static elements which resulted after further interventions on the supporting girders of the ground floor and especially by the recent installment of a new reinforced concrete floor between and above the wooden girders on the floor above when more than 2 square meters of ceiling painting detached

concrete floor, water broke through from the upper floor causing new damages in the shape of a number of large stains that were created by the partial melting of the connective material of the painted layer. The cement liquid which poured out of the insufficiently protected moulds of the new concrete supporting consoles additionally contributed to the surface salting-outs which contributed to the general impression of it being stained. The terminating side profilation, also decorated with paintings, smoothly joined the ceiling to the walls. It was in a relatively good condition but its terminating gilded wooden laths were highly damaged. Some were missing.

Because of everything said the inevitability of having to take down the entire painted ceiling was recognized. Whatever kinds of procedures in situ such as consolidating the mortar or attempts to level the disturbed levels of some parts of the painted ceiling were not an option because static shifts on the walls did not cease. Already during this phase of the undertaking, the far-reaching correct decision was made to use a new separate self-supporting construction for the painted ceiling which would maximally keep it separate from the constant static movement on the walls and enable it to exist independently within the network of encumbering mechanical forces.

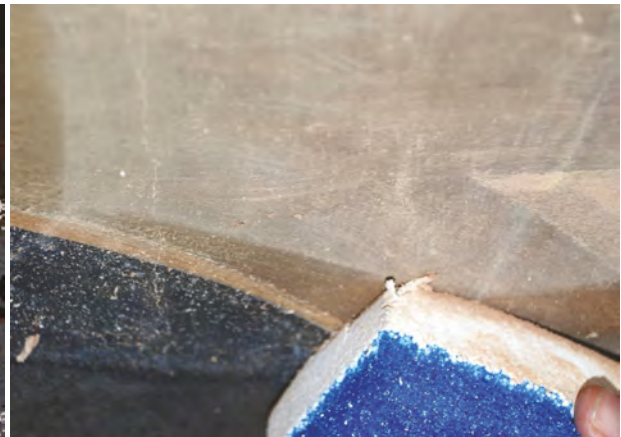
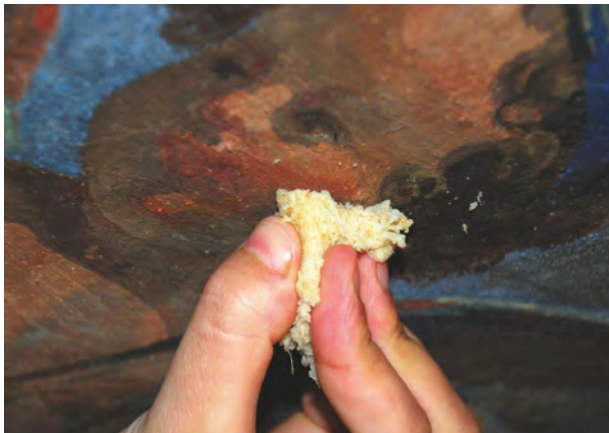
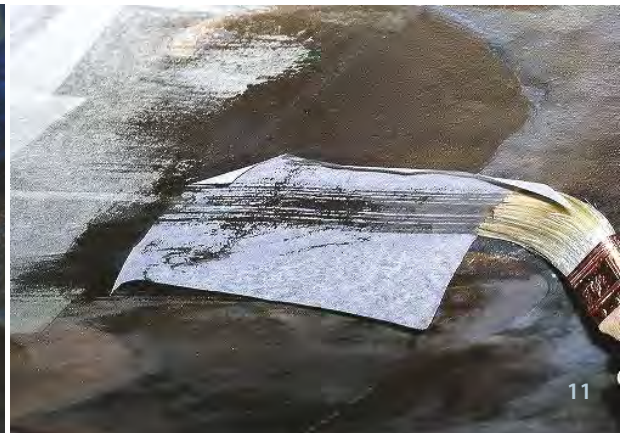
cleaning and preserving the front – consolidation of the painted layer

Preparatory work before the dismantlement of the ceiling consisted of a number of procedures which guaranteed maximum protection for the paintings from any additional damages. For this purpose, as an initial step, the rim profiled gilded wooden laths were removed. They were documented and stored for later interventions. Before the placement of a protective armature above the painted layer, it had to be thoroughly cleaned which was done by the careful abrasive procedure using Wishab sponges. As the next step, its pre-consolidation was carried out with a 2,5% solution of Paraloid in toluene. The fixing of the armature was done with brushes so as to have on the spot control over the results of the treatment. This procedure was repeated a number of times on the pulverized parts of the painting, particularly in spaces which had a predominantly blue pigment. This procedure equalized the absorption and consistency of the painted layer and created a temporary protective film which enabled the unhindered adhesion of the protective armature across the front of the painting. All the detached fragments were treated in the same manner.

The protective armature consisted of a layer of overlapping sheets of Japanese paper 15x15 cm large which was directly laid on the painted layer with an adhesive solution of glue in water, the ratio being 1:6. Afterwards two to three more layers of formatted gauze were laid down depending on the type and intensity of the damage on the front side of the painting. An integral and secure temporary protection of the front of the painting, which enabled the fragmentation of the ceiling, was put up through this process of glueing from beneath.

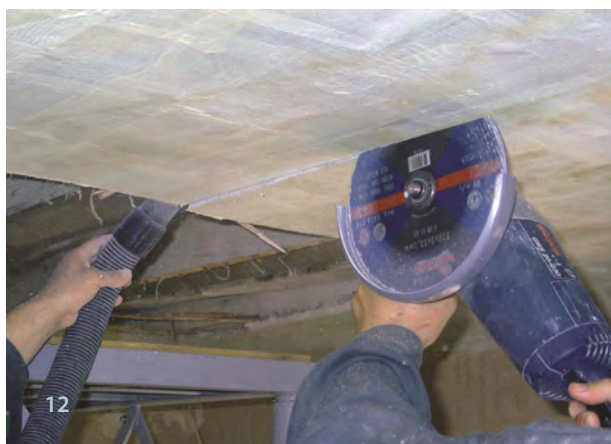
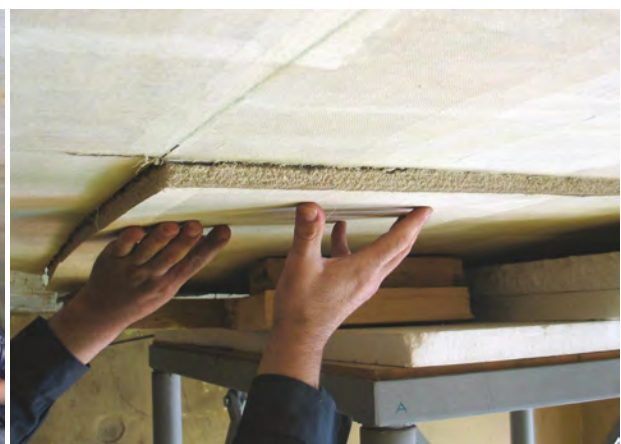
separation–dismantlement of the ceiling

A plan for cutting and detaching fragments of the ceiling was made on the prepared worksheet rendition of the paintings. Doing this one had to take account of two, frequently irreconcilable factors. The size, weight and the possibility of manipulating the fragments had to satisfy the technical criteria of the pre-planned project of taking down and returning them to the new suspension, while at the same time one had to keep in mind the adaptation of the cuttings to the figurative composition of the painting, reducing the destructiveness of the operation to a minimum. On the basis of the elaborated design, the lines of the cuttings were transferred and drawn on the front of the armature protection of the ceiling. In this manner it was divided into 43 numerized fields.

In order to simplify the stacco method, for this occasion an unfoldable metal moveable mount with a separate regulation of height on all four legs was constructed. An appropriate dependent plate whose dimensions corresponded to the individual fragment was placed on the mount. The regulation of height on four points gently supported the chosen fragment around which a precise cutting would be made along the drawn lines with an angular grinding machine, regulating the speed and the number of turns. After the cutting, by lowering the height of the mount, the fragment, after necessary interventions on its back-side, such as the snapping off of the healthy threads of the armature, would be simply separated from the corpus of the ceiling. Each fragment individually, together with its supporting plate which made possible easier transport and manipulation, was stored under the work platform. The whole process proceeded according to a precisely established lineup of separating the fragments, starting with the southeastern part of the ceiling where severe damages enabled a relatively easy start of defragmentation.

After the ceiling cover was taken down, the now wholly accessible girder construction was inspected. It was established that the leveling of the girders was not horizontal but that it drops approximately 15 cm in the east–west direction. The leveling was brought about by the forementioned hammering of boards in order for the reed screen to be set down in the most orderly manner. Thusly, on the eastern side, the gap between the layer of plaster and the supporting girders is in places more than 15 cm while on the western side the reed is fastened directly to the girders. This circumstance greatly influenced the decision to lower the entire level of the ceiling 20 cm because of the new self-supporting ceiling suspension and to conserve the original lateral profilation and leave it in the interspace.

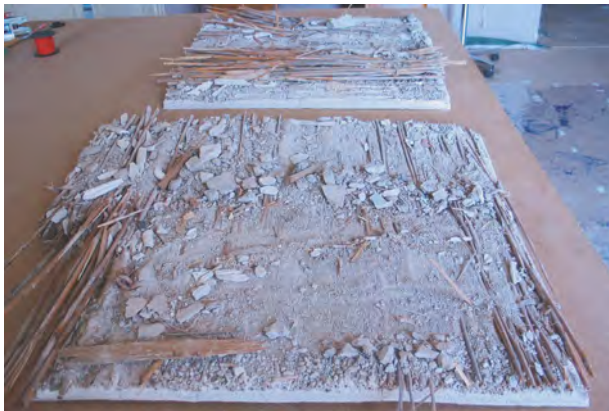
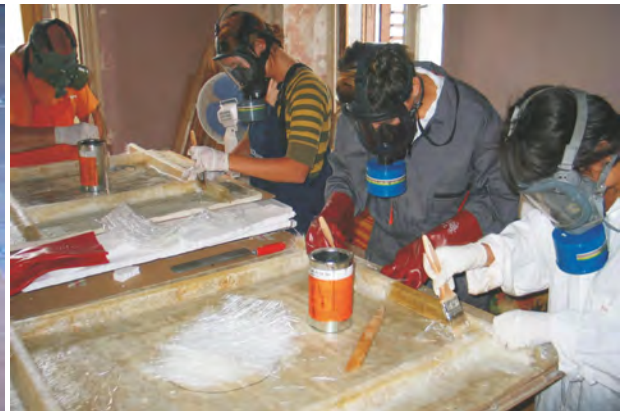
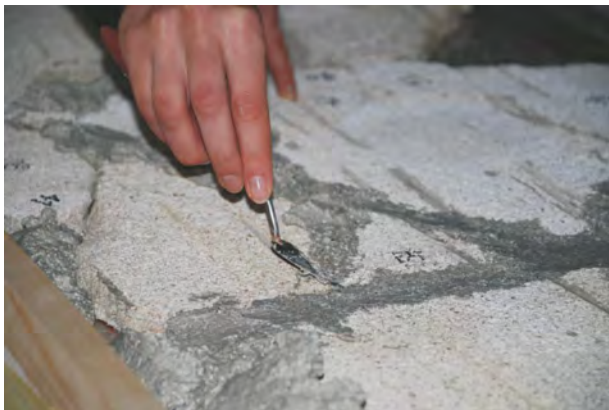
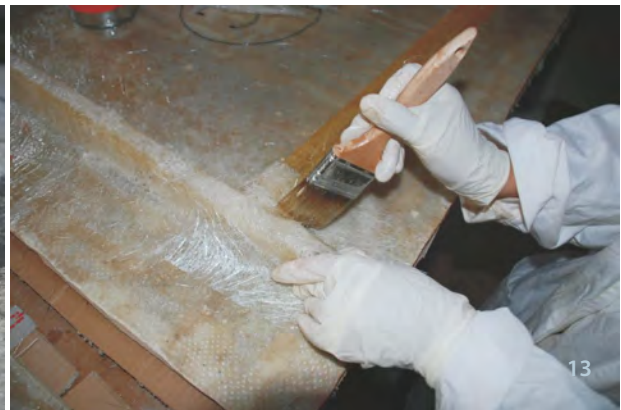
cleaning the reverse side, placing bracers, reconstructive procedures

The phase of cleaning the reverse side of the fragments inaugurated the process of preparing each individual fragment for accepting its own self-supporting back bracers. First all remnants of reed armature which had been penetrated by a layer of fresh plaster were removed. Its removal clearly revealed on the reverse side the uneven structure of plaster which in places was up to 2,5 cm thick. It was necessary to level it to the uniform height of 1,5 cm by removing the "surplus" of material with chisels and serrated scrapers. The level reverse surface was impregnated by a solution of primal AC33 in water which was applied three times with a broad brush. The ratio of the solution the first time was 1:5 while the other two times the ratio was 1:3. All the collected detached fragments were treated in the same manner but by submerging them in vessels containing the solution. The reverse surface showed the general condition of the fractured plaster which had spread more or less intensively throughout the entire structure of the material. The nature and the kind of damage on the plaster varied in width, length, depth and quantity on each fragment. Everything was salvaged by filling in all the fractures and lacunas as well as by repairing the chapped rims with the help of lime mortar with a primal additive. This procedure produced the firmness and compactness of the plaster necessary for the continuation of the restoration-conservation undertaking, while each fragment was given a conserved and restored underpinning which was made ready to accept its own self-supporting reverse side braces. These were put in place in such a manner that a thin layer of epoxid pitch reinforced by glass matte and roving was applied to the reverse side. After the reverse side was fortified in such a manner it was additionally braced by polyester U-profiles (approximately $h \times w = 4 \times 3$ cm in size) made of the same material and glued to the first armature layer in the same manner, preventing twisting and the possible cracking of the fragments. Thusly each detached ceiling fragment was given its own girder which maximally secured it and at the same time allowed it to be handled as an independent unit. Similarly, little slots were fixed to the back side of the fragments with the help of which they would later be hung on the suspension.

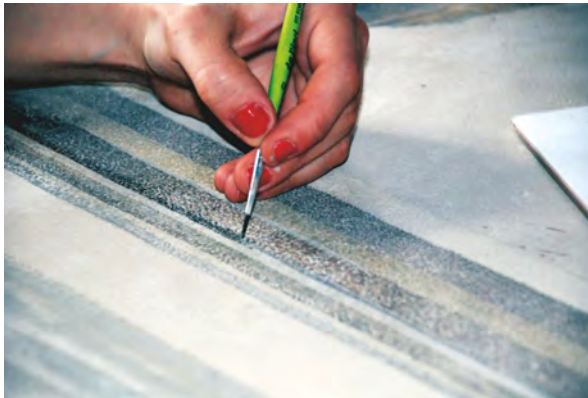
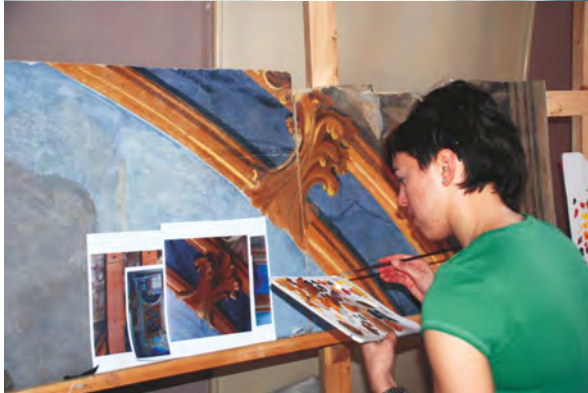
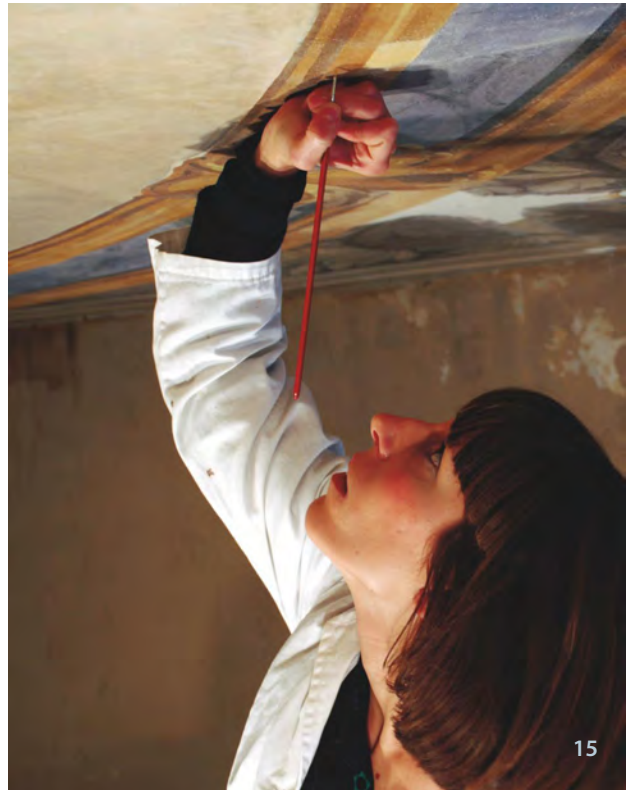
In these circumstances it was not easy to find the proper measure and a uniform approach to solving the problematic of the reconstruction retouching. Special MAIMERI colors for restoration were used which dry quickly and which after application have a reduced brilliance. These colors simplify the method of preparing the space under the painting, which has to be done if one is to arrive at suitable solutions to a series of demanding places in the reconstruction retouching process. These spaces under the painting are done with transparent varnish so that they resemble as much as possible the final impression of the original nuances of the painted layer. All the retouched surfaces on the segments of the detached painted ceiling were treated by the technique of dotting, which is best suitable in the context of granular textures of the original surface intonaco.

When treating the larger missing parts of the paintings a reconstruction drawing was made which was supplemented by retouching with transparently varnished underpinnings and by dotting. A measured quantity of solutions (rectified turpentine) regulated the thickness of the color for retouching which had an effect on the final matte effect of the applied retouched layer.

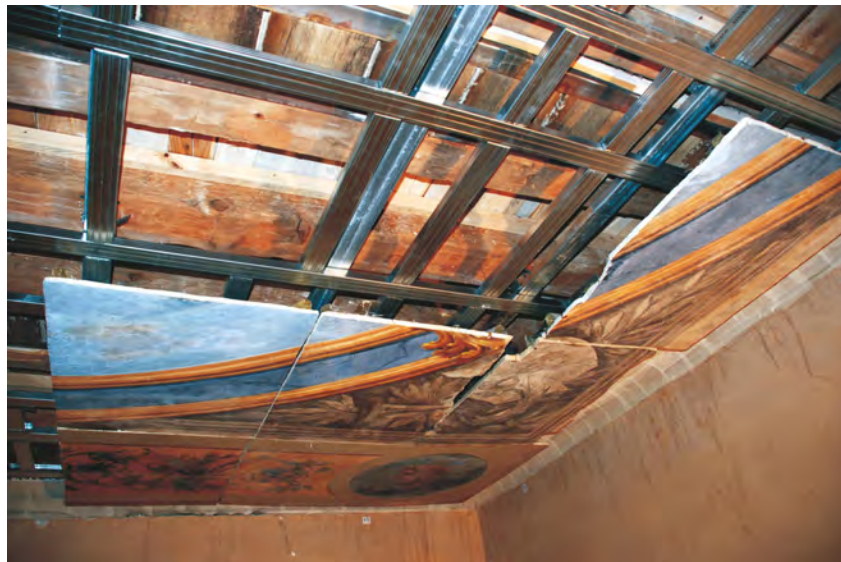
system for returning the detached segments

The uniqueness of the project of the restoration-conservation work done on the painted ceiling in the Bajamonti-Dešković palace consists in the way the detached segments of the painted ceiling were put back in place. Since there was no similar experience within the profession in our country, we had to wholly rely on our own experiences and the training of the entire team. The key problem was to solve the system of suspension and anticipate a series of technical, methodological and professional demands and doubts.

The biggest compromise was made in the form of sacrificing the original level of the painted ceiling which had to be lowered 25 cm in order to enable the implementation of a metal screen as the fundamental suspension. The metal screen was made out of special profiles of galvanized sheet metal which were anchored into the existing original supporting ceiling girders. Since we were dealing with a version of suspension which is used in building standard lowered ceilings a number of adaptations that would increase the carrying load had to be made. These adaptations had to take into account the specificities of every segment that was to be put back and the flexibility of the entire system in relation to the phenomenon of static and dynamic disruptions. The mobility of the cross-wise profiles of the screen enabled a better and more precise placement of the segments prepared for putting back in place. Every segment has 3 or 4 appended placement slots made of polyester fibers, depending on the size and position of the braces on the reverse sides of the segments, which position themselves on the elements of the suspension. Precision placement is facilitated by these details of free positioning and by the mobility of the auxiliary transversal elements of the metal screen. Positioning according to height is solved in a simple manner by putting wooden lamellas of varying width underneath which gives the desired position in accord with the surrounding returned segments of the painted ceiling. The positioning of each returned part is synchronized with the basic directions of the furthest rims which are controlled by connective points and controlling level lines with the aid of a spirit-level and a laser level.

Initially when thinking about the methodology of putting back the ceiling segments one of the proposals was screw-anchorage through the plaster of the detached segments. Additional thinking, accompanied by a series of calculations and simulated details, showed that this would be a bad solution. This manner of fastening would not withstand the tangle of static forces which would put a burden on every placement point in an unbalanced manner. This would inevitably result in the cracking of the adhesive material in the places where the joints are located. The screen of the metal suspension creates a "hovering" model which enables flexibility and the depreciation of possible uncontrolled outside influences such as blows, vibrations (earthquake), static disturbances and other unforeseen circumstances. Static and dynamic forces are evenly distributed throughout the entire surface of the returned painted ceiling and disappear without consequences, especially in the sensitive places where the joints are located. If pressure is put only on one point the kinetic energy is again dispersed onto all the elements of the suspension, disburdening the pressure point.

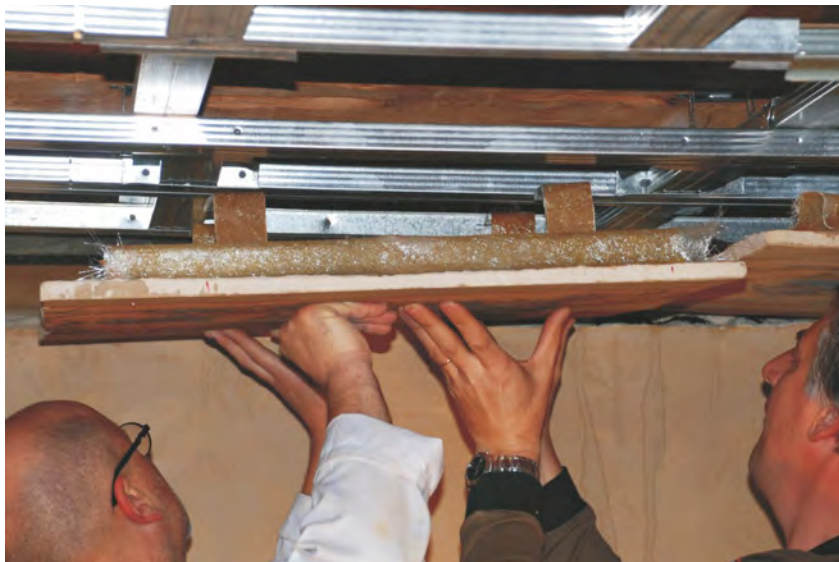
returning the fragments

The positioning of the first plate, which was being returned onto the described system of the metal suspension, finally determines the leveled lines of the rims which have to entirely accord with each returned ceiling segment. The places where the polyester placement slots are to be put are the first to be marked according to the pattern of longitudinal and transversal elements of the metal suspension. The placement slots were put in place by pasting epoxid pitch and smaller pieces of polyester fiber. After these solidified (it took them two days to dry) such a piece could be put on the suspension. Precision movements with wooden lamellas finally defined the position of the returned segment. Adhesive plaster, conforming to the original one, was applied within the spaces of the joints which means that it ought to have somewhat more pronounced characteristics of firmness and elasticity in order to evade the risks of subsequent cracking and crumbling. The positioned plate was immobilized by bindings, pegs and props in order to avoid movement which would cause cracking in the adhesive mass. The dynamics of the described procedure of putting back the segments of the painted wall was limited by the existence of the placement slots (recording, placement of epoxide, drying) and by the adhesive plaster within the joints so that at most two segments could be put back at one time.

Alongside the putting back of the segments, after the third had been put in place, the treatment of the joints was simultaneously being carried out and the harmonizing of the texture of the supporting plaster, as well as the preparation of these places for retouching. Supporting plaster or liquid plaster was applied to the adhesive mortar in the joints depending on the granulation of the original parts of the intonaco. Aligning it with the original texture of the plaster was accomplished by the application of fresh plaster, by the application of liquid plaster and by interventions with different tools on the dried plaster. It was only in a few restricted places that the disrupted level in the zone of contact of the returned segments was aligned by grinding and additional puttying. This was a consequence of dilatative alterations because the segments were taken down with existing warps and aberrations which could not be fixed in the final variant of the returned ceiling. In a number of critical places it was impossible to sufficiently equalize and level out the discordance of two segments in the zone of contact because of the delicacy of that place within the figural composition of the central medallion. As a rule, interventions on the area of faces, hands, equipment and other parts of figural images on paintings are not made during the process of restoration. This is the reason for the visible smaller uneven spots in the smaller restricted area of the joints.

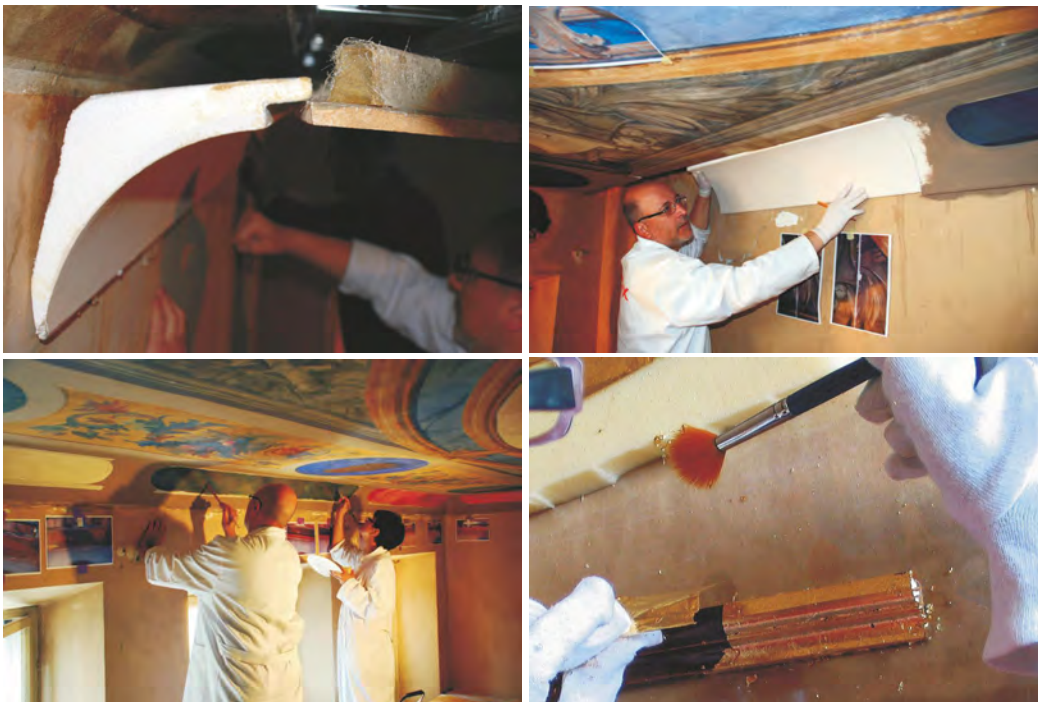
lateral profiling

Because of the shifting of the ceiling level in the said circumstances, the lateral profilings of the painted ceiling remain in situ conserved and restored by customary procedures. During the process of putting back the segments of the painted ceiling, lateral profiles of a simple semicircular cut 32 cm in radius were simultaneously put in place. An industrial product specifically adopted to the demands of restoration work on painted ceilings was used (the firm OKIPOR co.-Konjsko). The product consists of a styrodur core coated with silicate plaster in segments measuring 2 m, in such a manner that it complies with the main requirements of material suitable for reconstruction: small weight, simple removal (reversibility) if necessary, compatibility with other materials, easy treatment and handling and acceptable price. Along its entire length its upper part has a groove which settles on the returned ceiling segments and which after placement is filled in with adhesive material whose function is to securely connect the zone of the wall with the zone of the returned ceiling. The lower part of the profile lies on the laths in order to avoid shiftings and is directly attached to the wall with construction glue. After stiffening, the entire surface of the lateral profile is coated with two layers of liquid plaster which will at the same time serve as underpinning for reconstruction retouching. First, according to its original shade, the color which covers the background surface of the profilation was prepared. In accordance with the original sample of marbleization, two variants of red and blue-green imitation marble were reconstructed using the effects of transparent varnish forms and more emphatic accents. The reconstruction retouching was carried out with acrylatic colors keeping in mind its final effects in the sense of the shading of the colors, their necessary brilliance and steadfastness.

Decorative gilded laths were placed in the lower part of the profile following the lower rim. According to the original model new ones were made from spruce wood and prepared for gilding. All were impregnated with a number of layers of PARALOID and subsequently grinded with fine grindstone paper in order to prepare the base as best as possible for the application of bolus and mixtion. Bolus was applied in a dark red nuance in two layers. The second layer was grinded. It was finally polished and cleaned with a soft cloth. 24-hours mixtion was used and golden leaves (imitation), which we had previously formatted with a special knife into smaller pieces for easier placement, were put in place. After 24 hours the gilded surfaces were polished with absorbent-cotton wads and soft cloths, removing the residues of golden leaves. After a few days the gilding was given protective coating with two layers of copal varnish and with a patinated patina made out of an asphalt base, of copal varnish and Venetian turpentine for the purpose of diminishing the inappropriate brilliance of the gilding. Laths were put in place by pasting with acrylatic glue in order to avoid hammering in nails.
